# UNDERWATER BRIDGE INSPECTION REPORT

STRUCTURE NO. L9641

BLACK RIVER

MINNESOTA DEPARTMENT OF TRANSPORTATION  
UNDERWATER BRIDGE INSPECTION

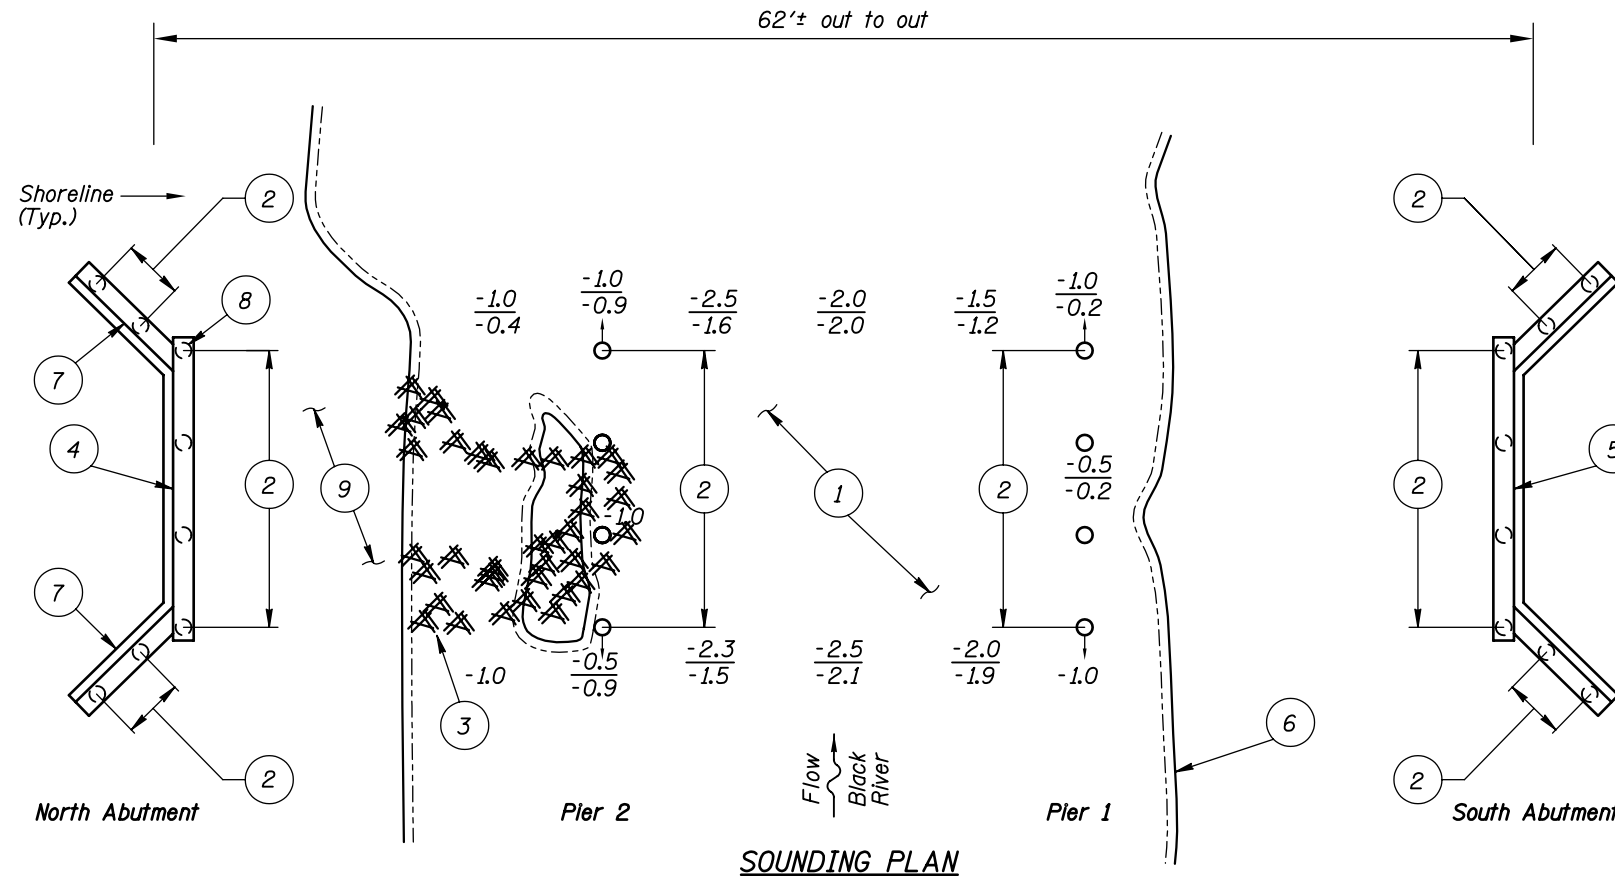
**INSPECTION AND SOUNDING PLAN**

- 1 Channel bottom consisted of sandy clay with maximum probe rod penetration 1 to 1.5 feet.
- 2 Random checking on all piles measuring 1/8 to 1/4 inch in width.

- 3 Moderate accumulation of timber debris on and around shallow island between the North Abutment and Pier 2, with logs and branches measuring 1 foot in diameter and smaller.

- 4 Pile cap movement to north on North Abutment up to 2 inches maximum on the west end.
- 5 Pile cap movement on South Abutment, twisted south, causing the cap not to bear on most of the piles.

- 6 Minor erosion observed along the south bank.
- 7 Wingwalls leaning/shifting backwards at both ends of the North Abutment, with up to 6 inches of movement and separation between piles and wall planks.

- 8 A 1-1/2 inch wide split was observed and extended from the top of the pile down 3 feet along the pile.
- 9 Up to 2 feet in diameter riprap was observed at the North Abutment.

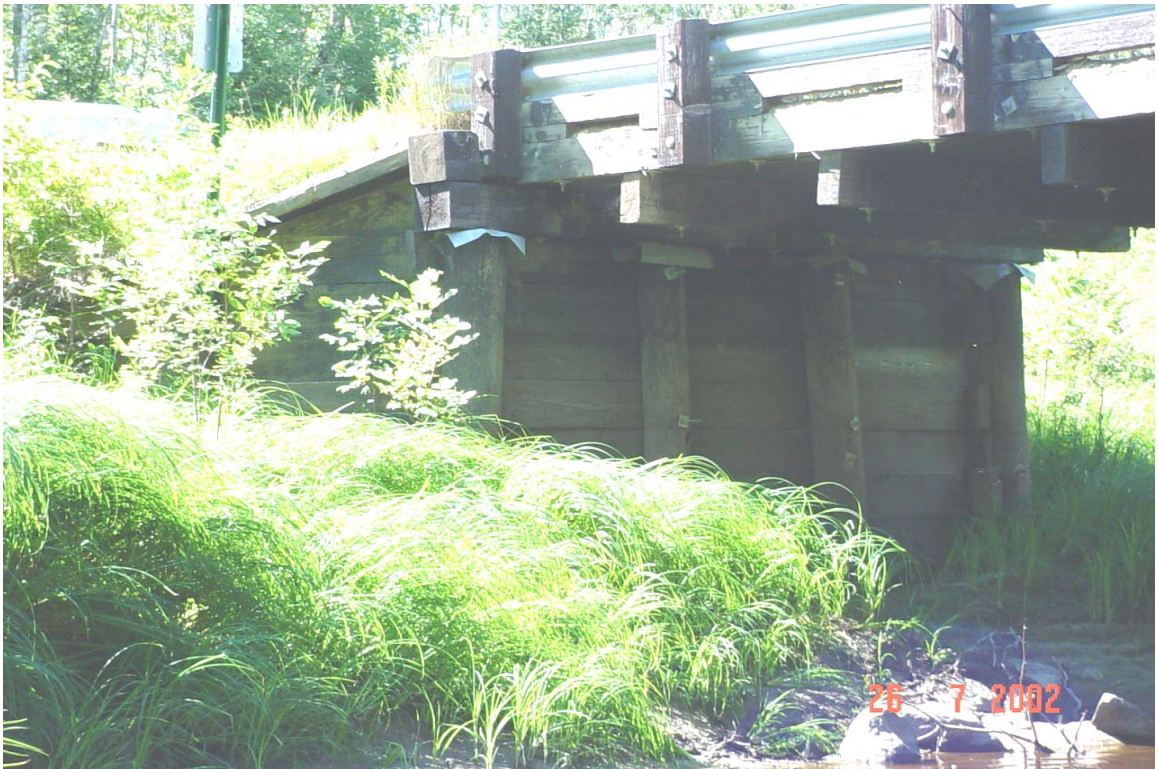
Photograph 2. View of the South Abutment, Looking Southwest.

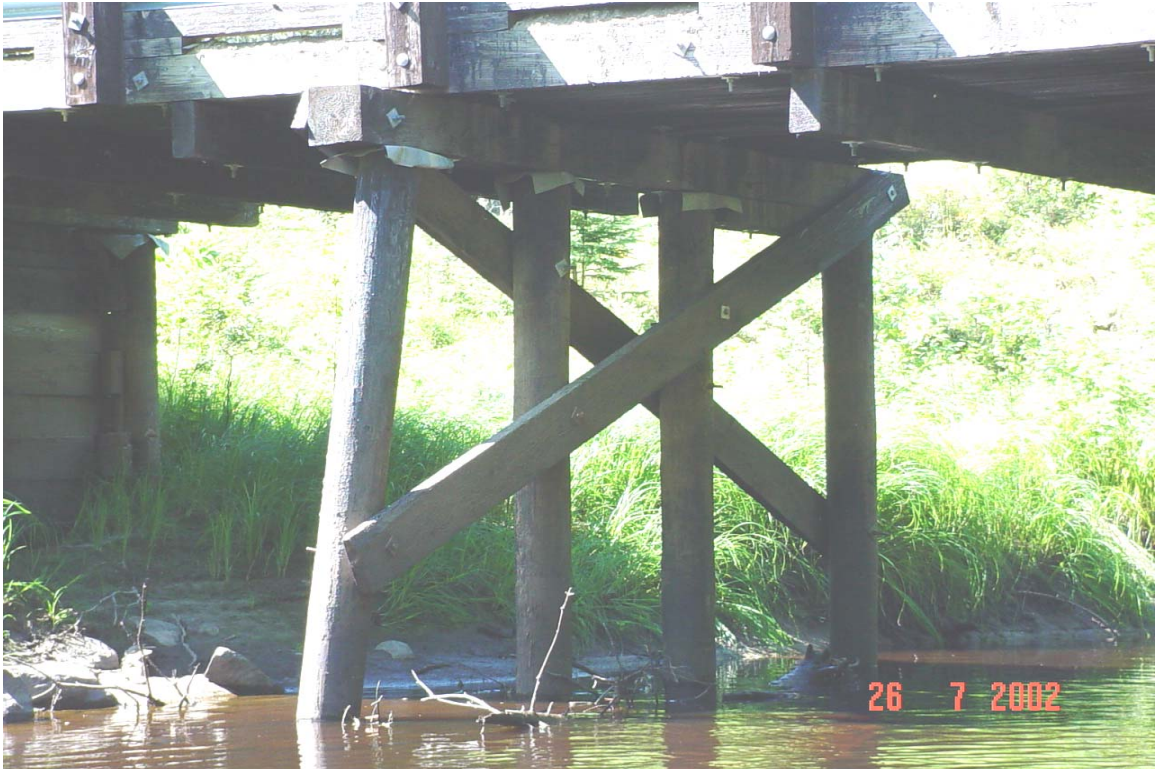
Photograph 3. View of Pier 1, Looking Southwest.

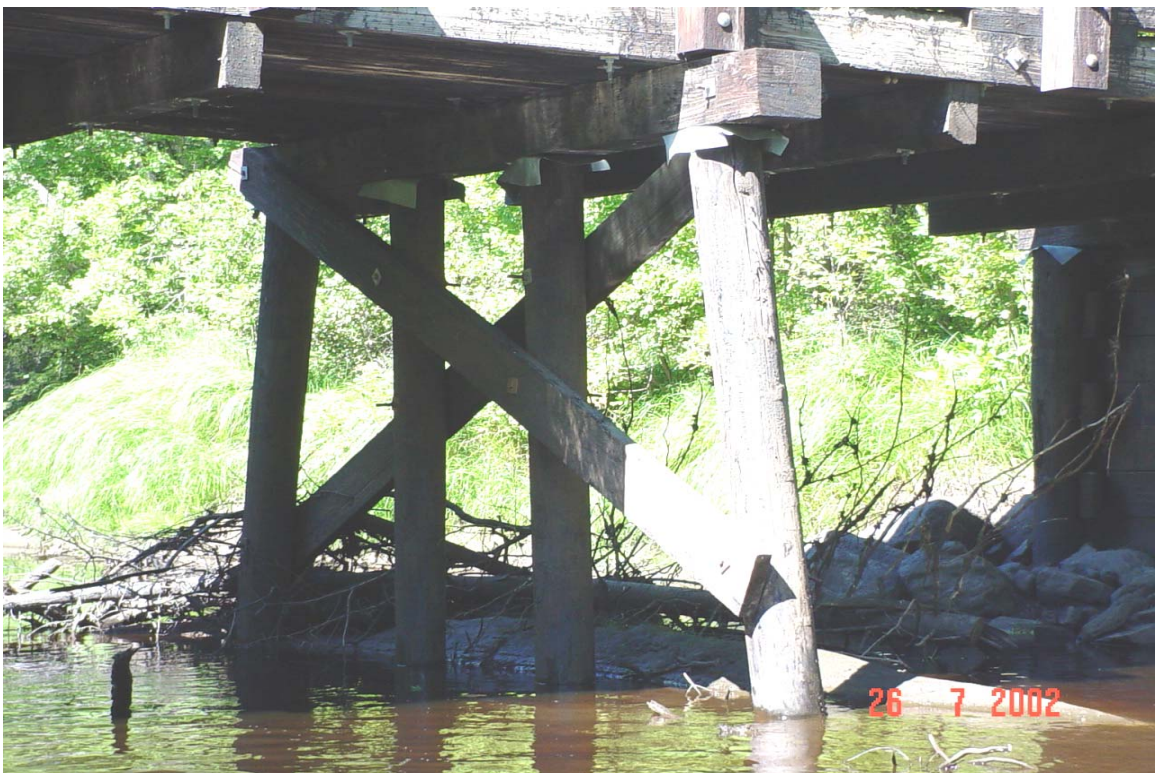
Photograph 4. View of Pier 2, Looking Northwest.

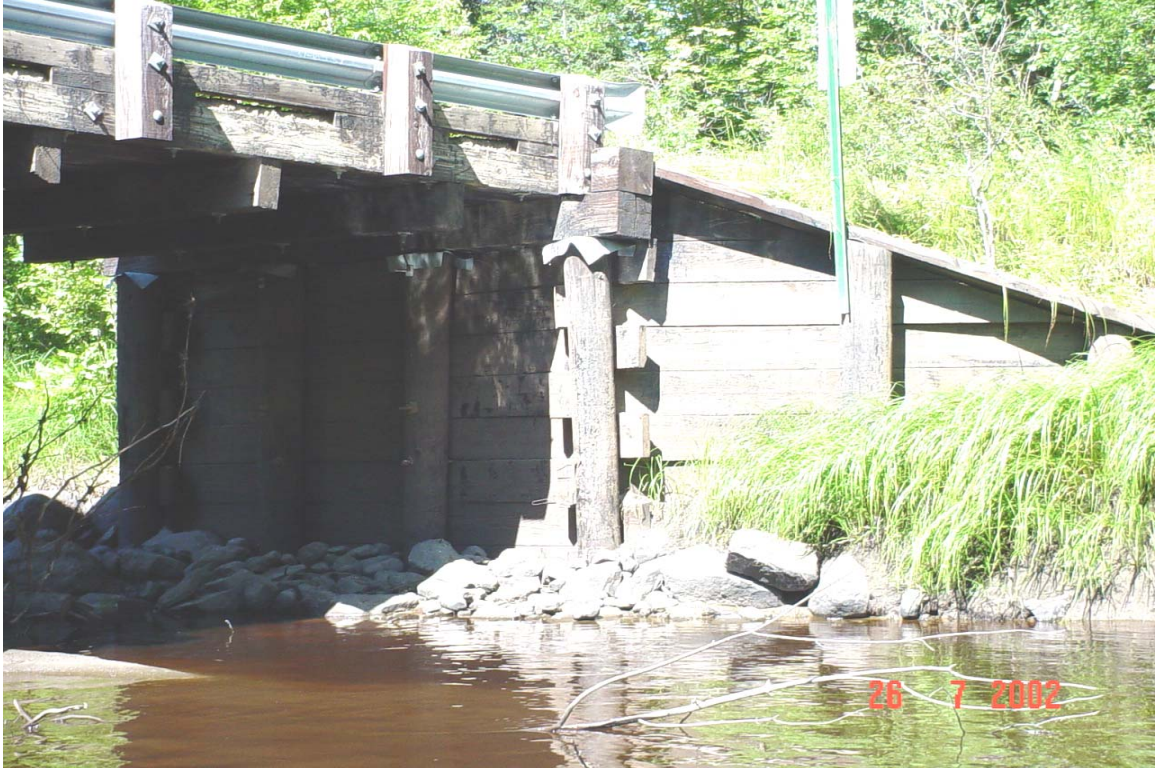
Photograph 5. View of the North Abutment, Looking Northwest.

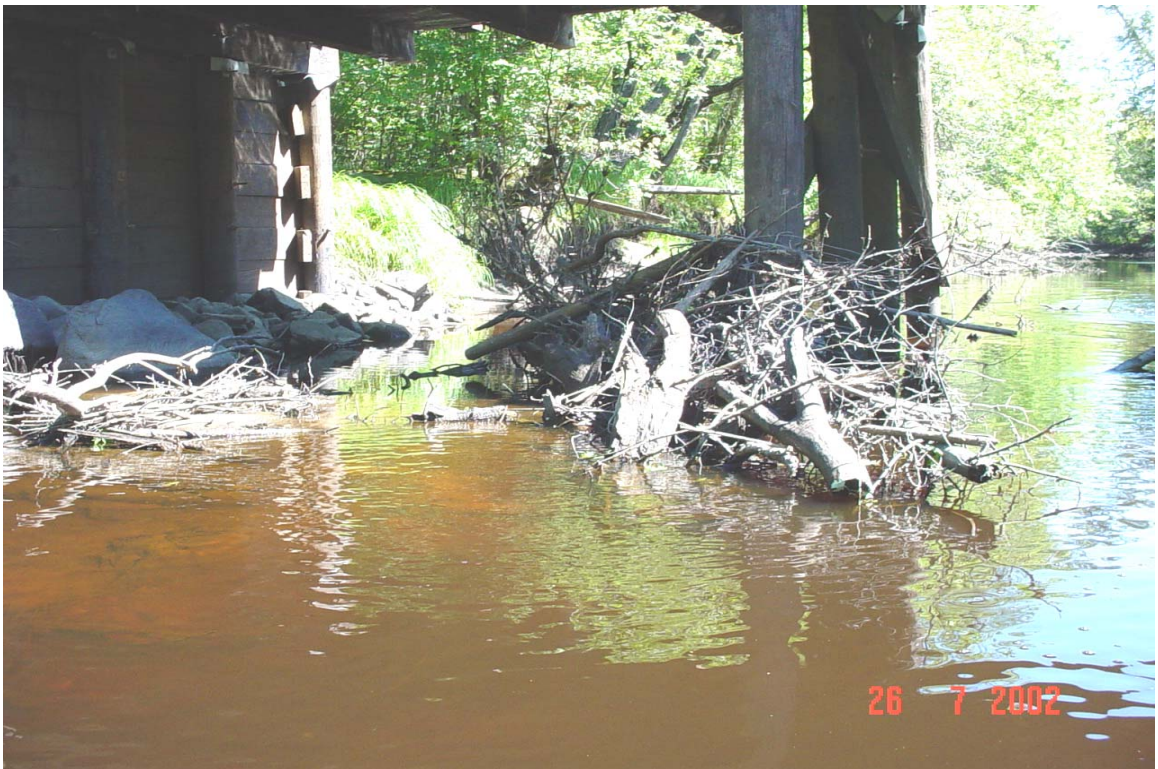
Photograph 6. View of Timber Drift Accumulation at Pier 2, Looking East.

- (A) Monitor drift accumulations, and if found to be increasing, remove during routine maintenance.
- (B) Reinspect the submerged substructure units at the normal maximum recommended (NBIS) interval of five (5) years.

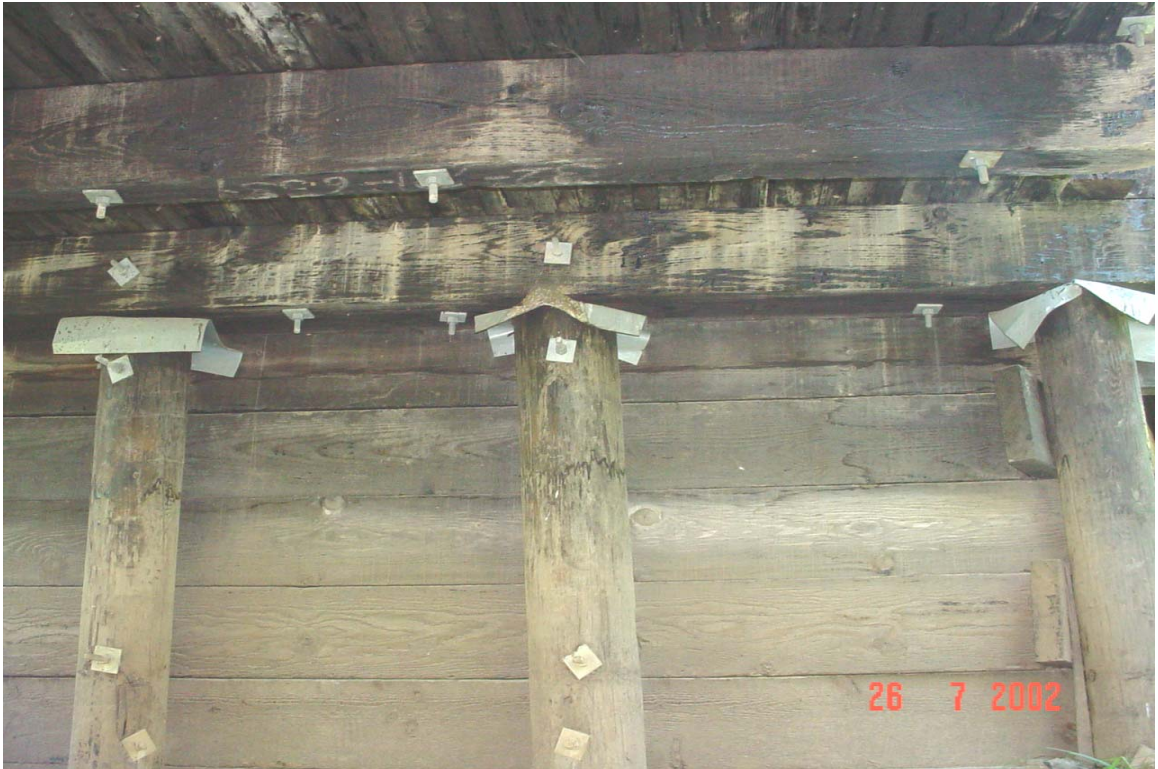
Photograph 7. View of Non-Bearing Piles at the South Abutment, Looking South.

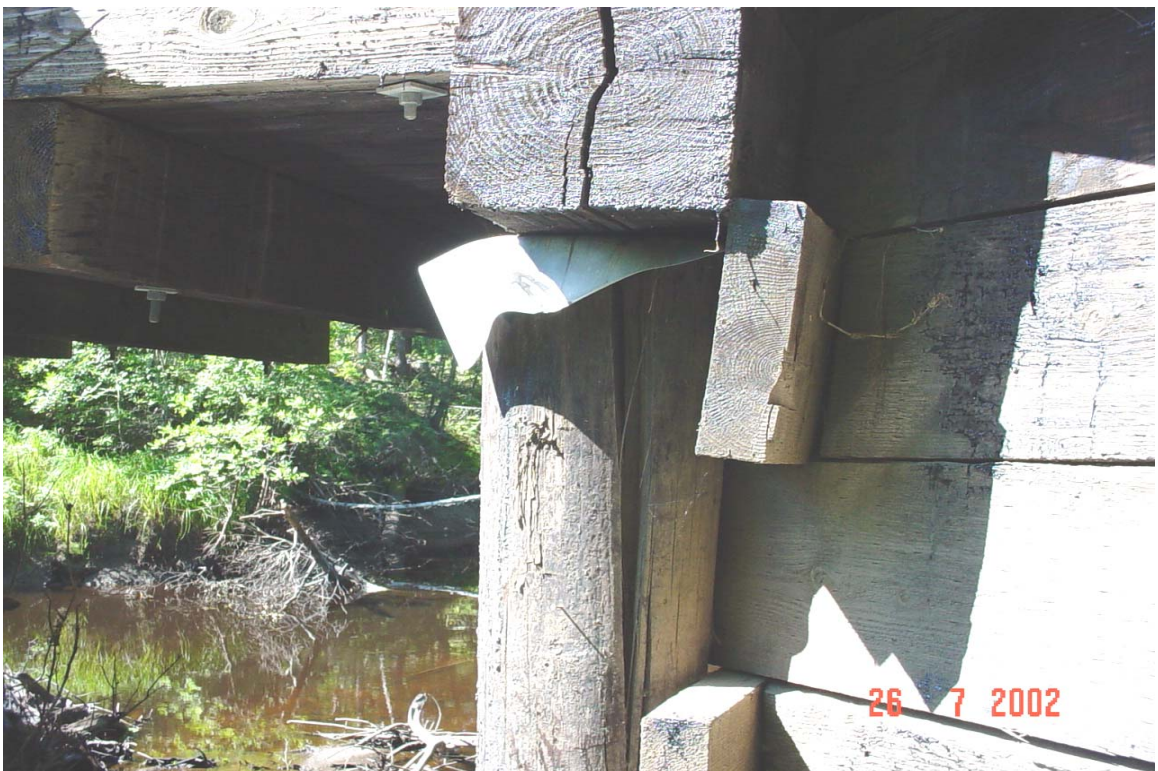
Photograph 8. View of Split in the Downstream Pile of the North Abutment, Looking West.
